New Hampshire Volunteer Lake Assessment Program

2002 Bi-Annual Report for Messer Pond New London

Messer Pond, New London

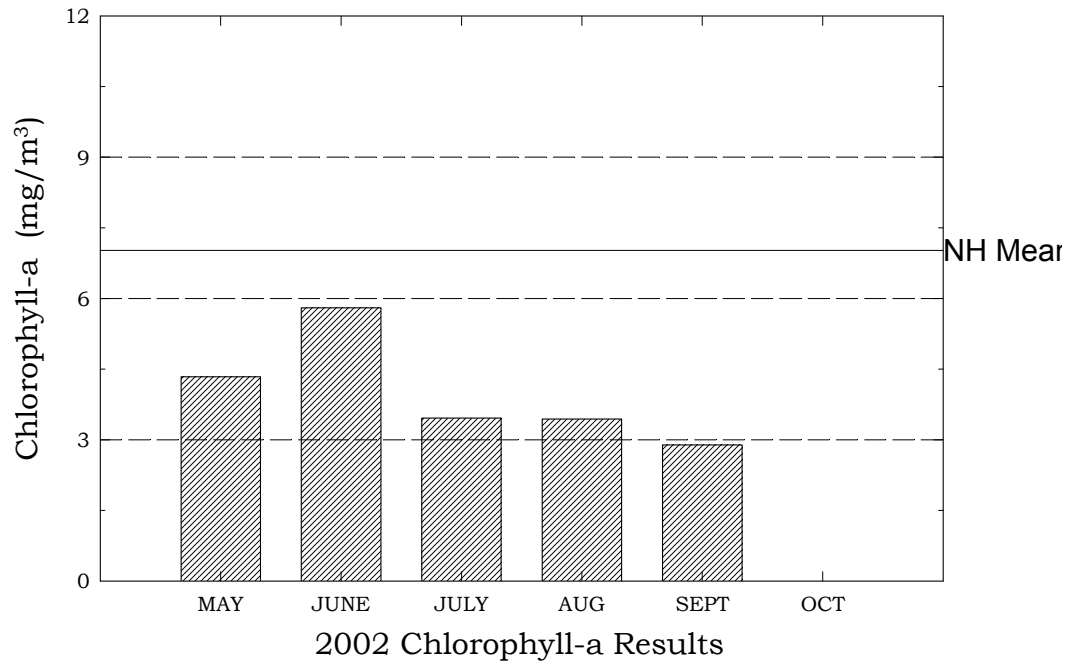
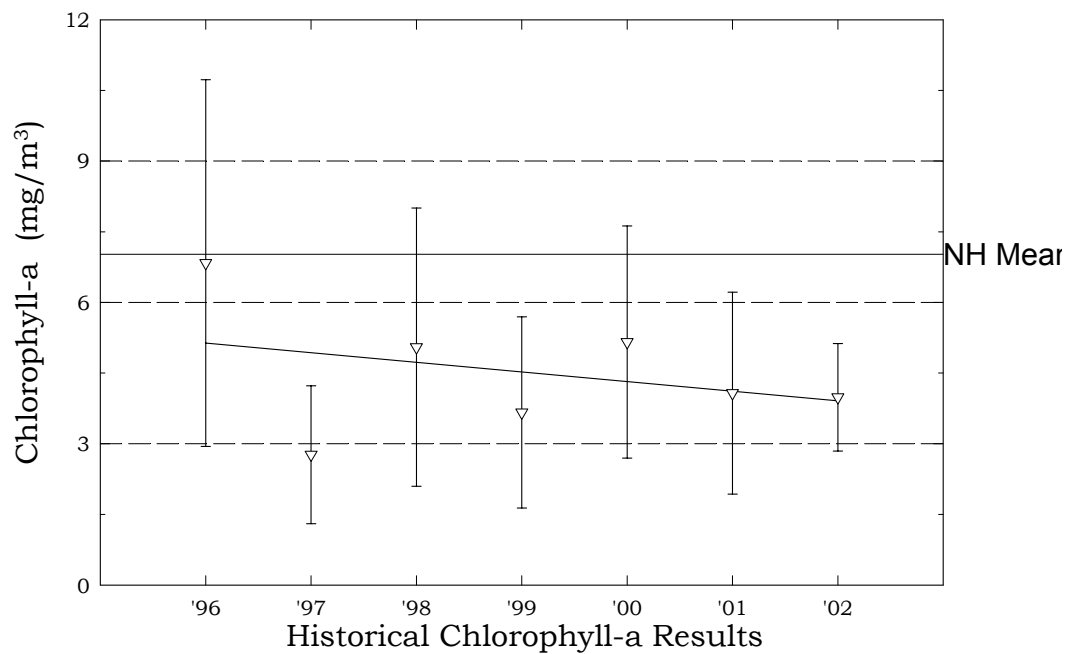
Figure 1. Monthly and Historical Chlorophyll-a Results

The current year data (the top graph) show that the chlorophyll-a concentration **increased** from May to June, **decreased greatly** from June to July, **remained relatively stable** from July to August, and then **decreased slightly** from August to September.

The historical data (the bottom graph) show that the 2002 chlorophyll-a mean is **less than** the state mean.

Overall, visual inspection of the historical data trend line (the bottom graph) shows **a variable** in-lake chlorophyll-a trend, meaning that the concentration has **fluctuated** since monitoring began in 1996.

- **Figure 1 and Table 1:** The graphs in Figure 1 (Appendix A) show the historical and current year chlorophyll-a concentration in the water column. Table 1 (Appendix B) lists the maximum, minimum, and mean concentration for each sampling season that the lake/pond has been monitored through the program.

While algae are naturally present in all lakes/ponds, an excessive or increasing amount of any type is not welcomed. In freshwater lakes/ponds, phosphorus is the nutrient that algae depend upon for growth. Therefore, algal concentrations may increase when there is an increase in nonpoint sources of nutrient loading from the watershed, or in-lake sources of phosphorus loading (such as phosphorus releases from the sediments). It is important to continually educate residents about how activities within the watershed can affect phosphorus loading and lake quality.

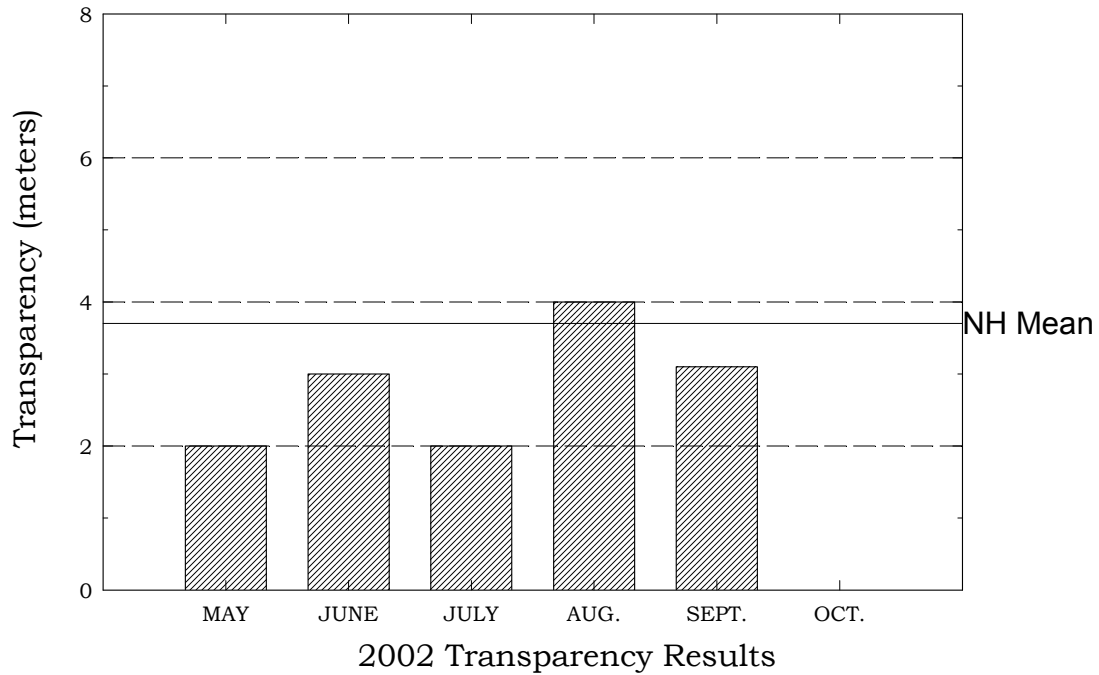
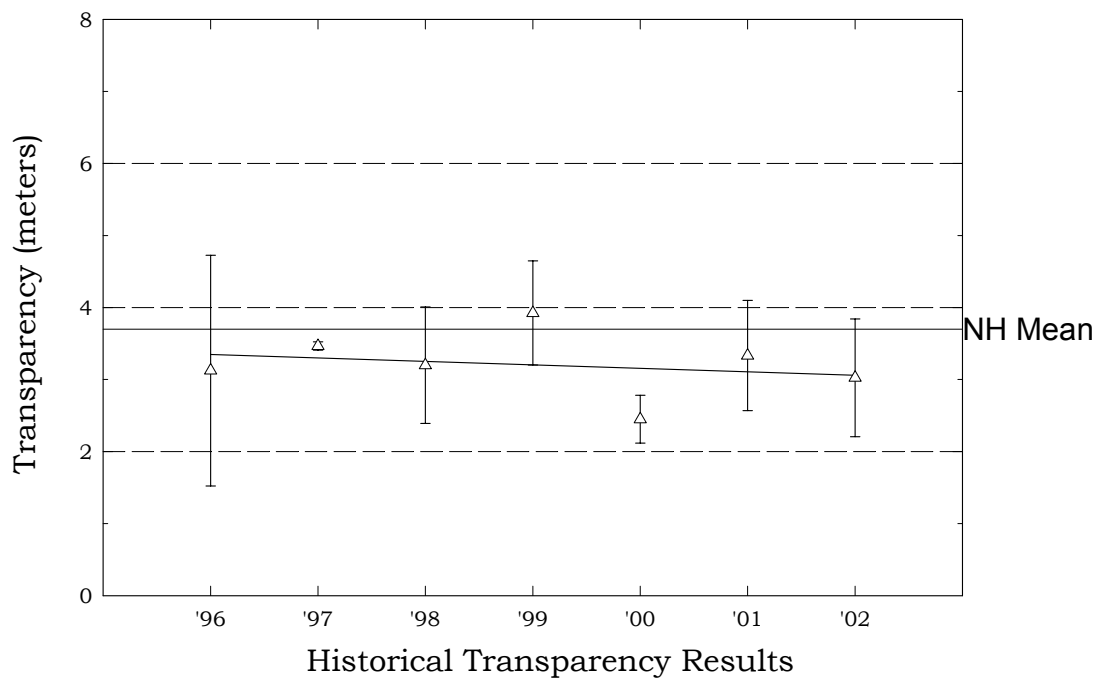
Figure 2. Monthly and Historical Transparency Results

The current year data (the top graph) show that the in-lake transparency **increased** from May to June to July, **decreased** from June to July, **increased** from July to August, and then **decreased** from August to September. The transparency in August was **slightly greater than** the state mean.

The historical data (the bottom graph) show that the 2002 mean transparency is **less than** the state mean.

Overall, visual inspection of the historical data trend line (the bottom graph) shows **a relatively stable** trend for in-lake transparency. Specifically, the mean annual transparency has ranged from approximately **2.5 to 4.0 meters** since monitoring began in 1996.

- **Figure 2 and Table 3:** The graphs in Figure 2 (Appendix A) show historical and current year data for lake/pond transparency. Table 3 lists the maximum, minimum and mean transparency data for each sampling season that the lake/pond has been monitored through the program.

Typically, high intensity rainfall causes erosion of sediments into lakes/ponds and streams, thus decreasing clarity. Efforts should continually be made to stabilize stream banks, lake/pond shorelines, disturbed soils within the watershed, and especially dirt roads located immediately adjacent to the edge of tributaries and the lake/pond. Guides to Best Management Practices designed to reduce, and possibly even eliminate, nonpoint source pollutants, such as sediment loading, are available from NHDES upon request.

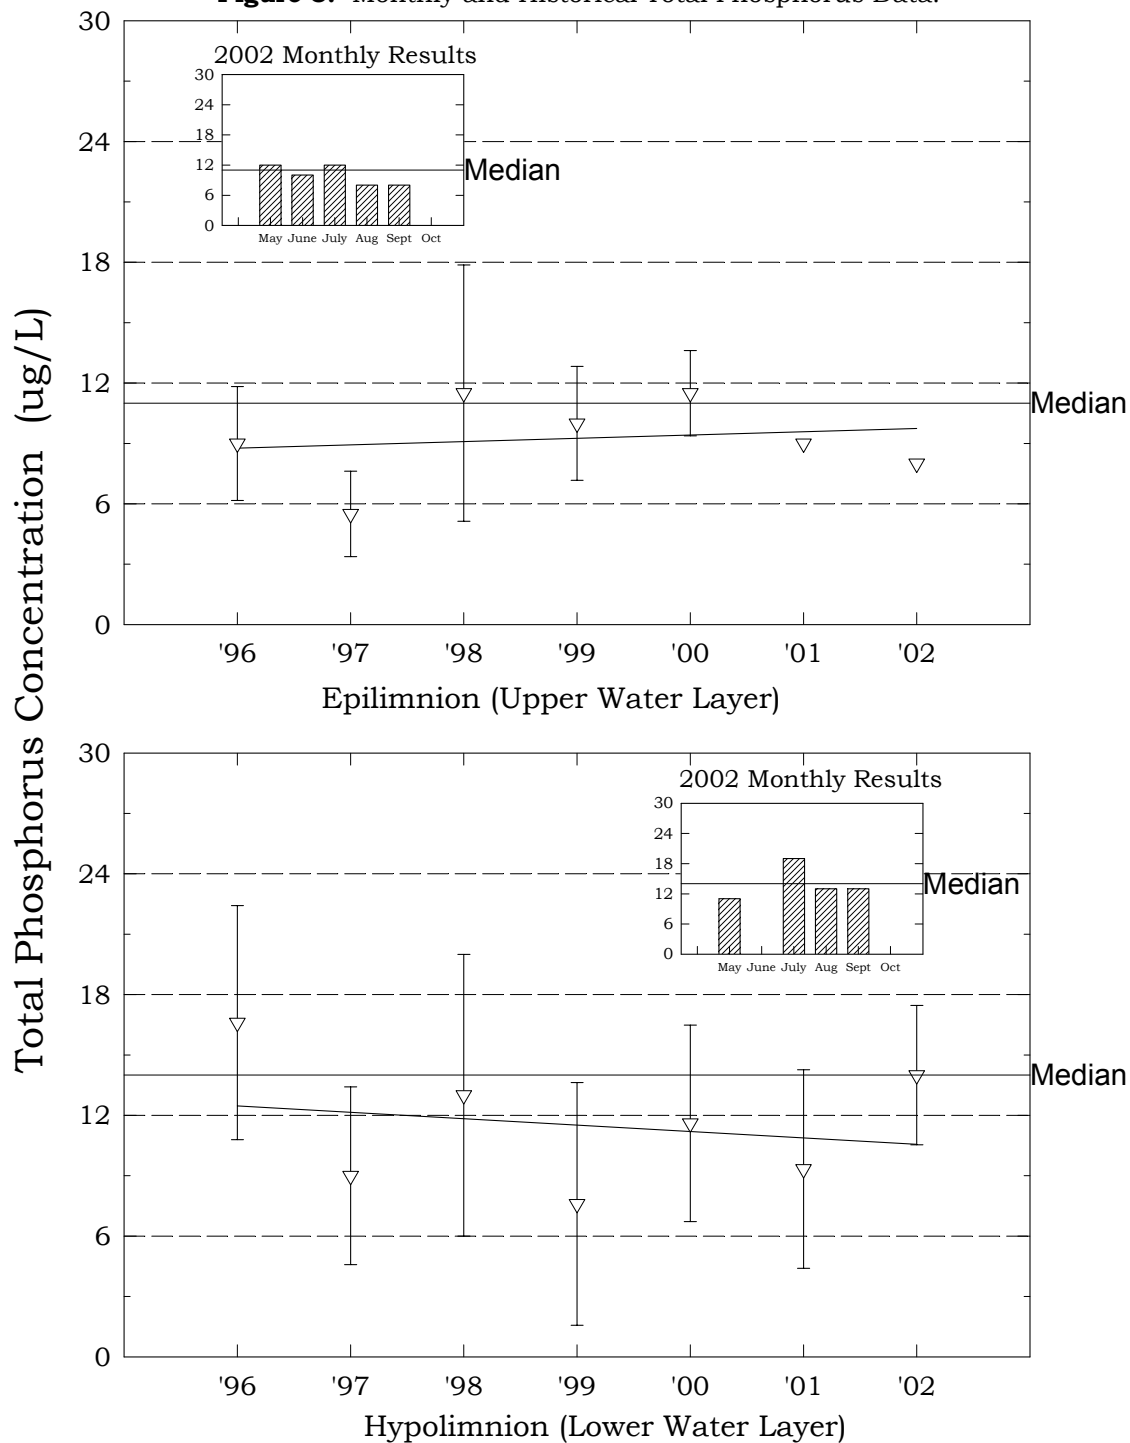
Figure 3. Monthly and Historical Total Phosphorus Data.

The current year data for the epilimnion (the top inset graph) show that the total phosphorus concentration **decreased slightly** from May to June, **increased slightly** from June to July, **decreased** from July to August, and then remained **relatively stable** from August to September. The total phosphorus concentration in May and July was **slightly greater than** the state median.

The historical data show that the 2002 mean epilimnetic total phosphorus concentration is **less than** the state median.

The current year data for the hypolimnion (the bottom inset graph) show that the total phosphorus concentration **increased** from May to July, and **decreased** from July to August, and then **remained relatively stable** from August to September. The total phosphorus concentration in July was **greater than** the state median.

The historical data show that the 2002 mean hypolimnetic total phosphorus concentration is **approximately equal to** the state median.

Overall, visual inspection of the historical data trend line for the epilimnion and the hypolimnion show **a variable** total phosphorus trend, which means that the concentration has **fluctuated** monitoring began in 1996.

- **Figure 3 and Table 8:** The graphs in Figure 3 (Appendix A) show the amounts of phosphorus in the epilimnion (the upper layer) and the hypolimnion (the lower layer); the inset graphs show current year data. Table 8 (Appendix B) lists the annual maximum, minimum, and median concentration for each deep spot layer and each tributary since the lake/pond has joined the program.

One of the most important approaches to reducing phosphorus loading to a waterbody is to continually educate watershed residents about its sources and how excessive amounts can adversely impact the ecology and value of lakes and ponds. Phosphorus sources within a lake or pond's watershed typically include septic systems, animal waste, lawn fertilizer, road and construction erosion, and natural wetlands. If you would like to educate watershed residents about how they can help to reduce phosphorus loading into the lake/pond, please contact the VLAP Coordinator.
